BASELINE GEOMORPHIC ASSESSMENT OF TOLAY CREEK SONOMA COUNTY, CALIFORNIA

A REPORT PREPARED FOR SONOMA LAND TRUST

JUNE 2009

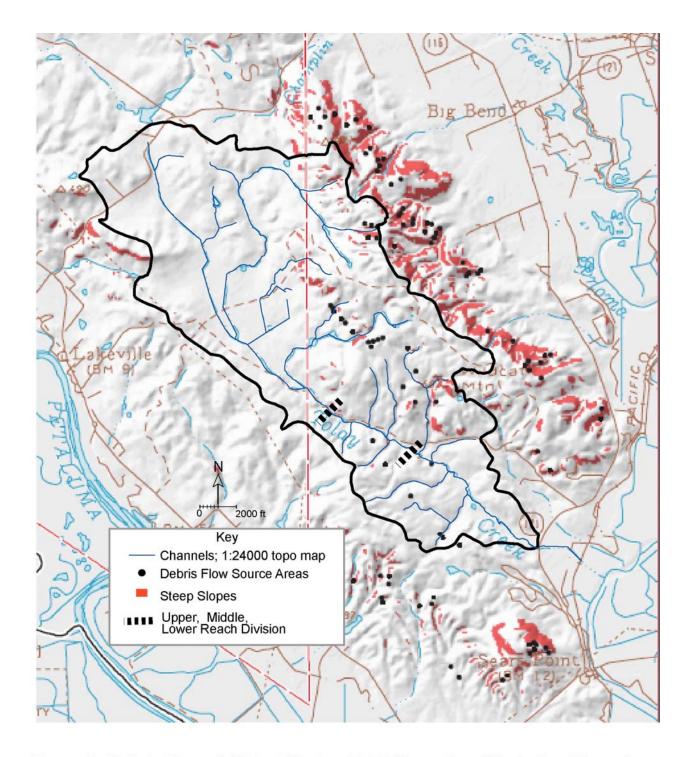
Figure 5. Debris Flows Initiated During 1982 Storm (modified after Ellen et al., 1997).

magnitude and high intensity storms such as occurred during 1982 initiated debris flows that were mapped by the USGS (Ellen, et al., 1997). This effort mapped areas highly susceptible to debris flows on the northeastern slope of the Tolay watershed (Figure 5).

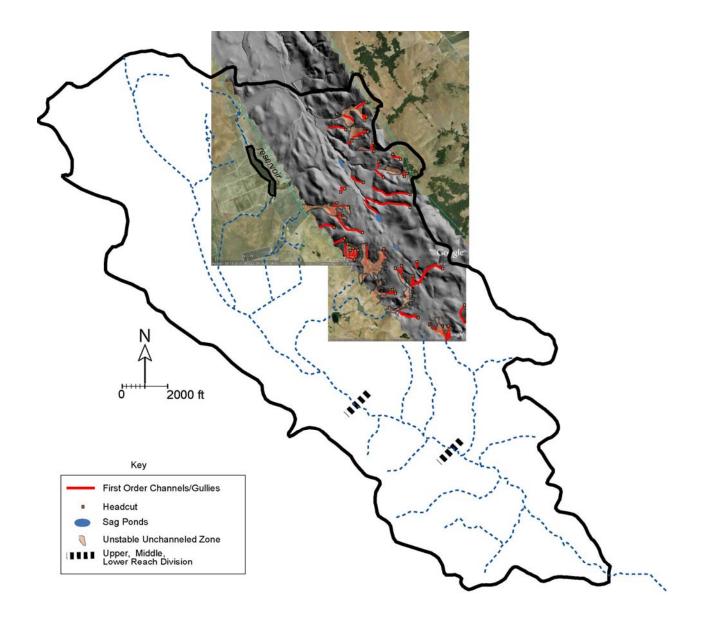
Figure 6. Sediment Source Areas Along Rogers Creek Fault Zone. Fault zone is indicated by grey-scale color.

Active tributary erosion is prevalent throughout the watershed. In the upper portion of the watershed, erosion and depositional processes are greatly influenced by the presence of the Rogers Creek Fault zone along the northeastern ridge and to anthropogenic activities on hillslopes and in the low gradient lake basin. Sediment sources along the Rogers Creek Fault zone visible in the recent LiDAR image (Figure 6) illustrate

numerous erosion processes in the upper portion of the watershed. First, hillslope instability is evident in unchanneled zones upslope from channel heads, where hummocky topography is an indicator of past and recent debris slides that contribute sediment to first order tributaries. Some debris slides are associated with debris flow tracts, illustrating the mechanism responsible for transporting sediment from hillslopes the drainage network. Second, gullies form in many locations within these and other unstable areas, providing a conduit for sediment to quickly reach channels during storms. The channelized zone of many tributaries begin downstream of wet swales filled with Holocene alluvium; such hillslope wetlands are vulnerable to erosion by headward migration of tributary erosion and from upstream changes in hydrology due to roads or vineyards. Third, bank erosion along the interface of the hillslope with first order channels is prevalent (e.g. as along the small channels forming the headwaters of Cardoza Creek). Coarse and fine sediment contributed to small first-order channels moves episodically downstream during storms.
