O'Donnell Lane over Calabasas Creek Bridge Update May 2024

Sonoma County Public Infrastructure was notified of a traffic accident on the O'Donnell Bridge (Bridge No. 20C0324) in late December 2023.

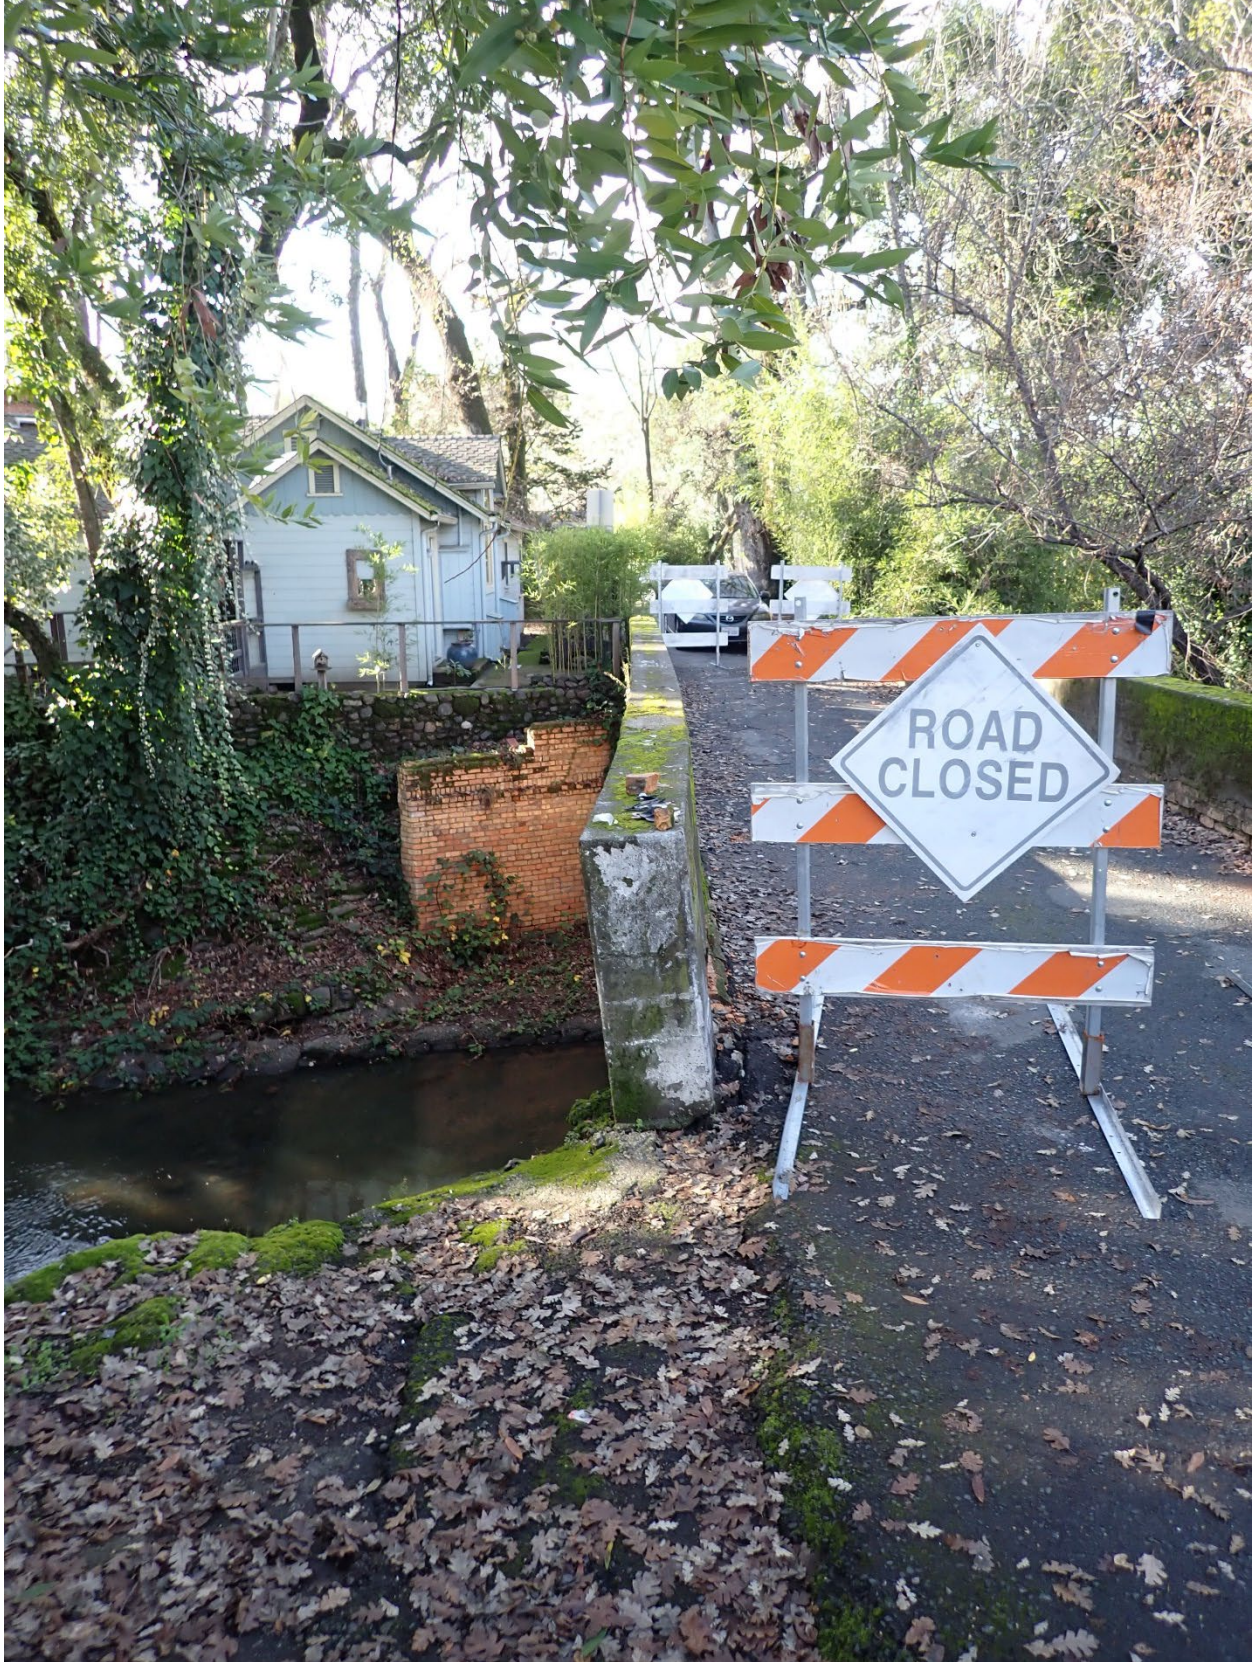
- Photo 1 – A photo showing how far out of true this collision knocked the rail. The rail is supposed to be straight.
- Photo 2 – A photo showing the section of bricks on the headwall that were displaced. A red line to highlights the demarcation.
- Photo 3 & 4 – Showing the condition of the rail as of Jan 4, 2024.
- Photos 5 & 6 – General View of the bridge

Photo 1 – Rail Displacement

The repair will require the services of a qualified expert in historic masonry restoration for the brick portions. Repairing the concrete will ideally require a specialist to re-cast the damaged section to match the appearance of the existing rail. Sacrificial bollards on either end of the bridge are recommended to protect the railing from being struck in the future.

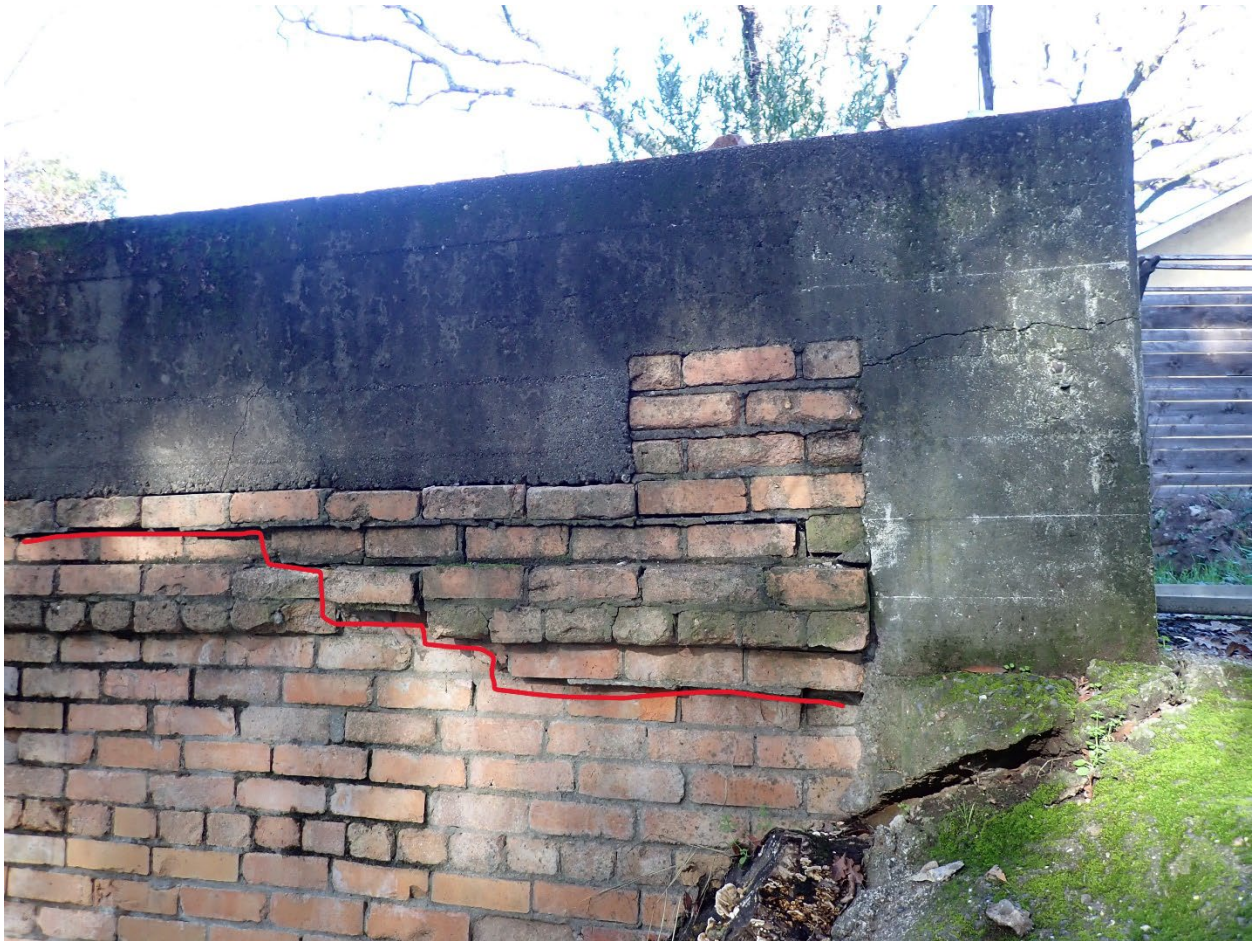
It appears that the original bridge may have only had a brick curb, and the concrete rail was cast on-top of the curb at a later date. The rail is not properly anchored to the bridge. This recent collision caused damage to propagate down into the headwall. The arch is filled with earth, which supports the roadway. The earth is retained by the headwall. The headwall was previously noted for signs of distress from overloading, which has now been exacerbated by this collision. As it stands, this collision has increased the vulnerability of the headwall to a greater structural failure from vehicular overloading. This bridge has experienced a recent increase of truck traffic servicing fire-burn redevelopment nearby. If the rail is struck again, there is a high likelihood that the rail will fail completely, along with a portion of the headwall, which would result in long-term closure of the bridge and irreversible damage to historic features. It could potentially allow the vehicle to fall over the edge of the roadway into the creek. The curb-to-curb width is 10 ft, so another collision is likely.

Photo 2 – Headwall damage

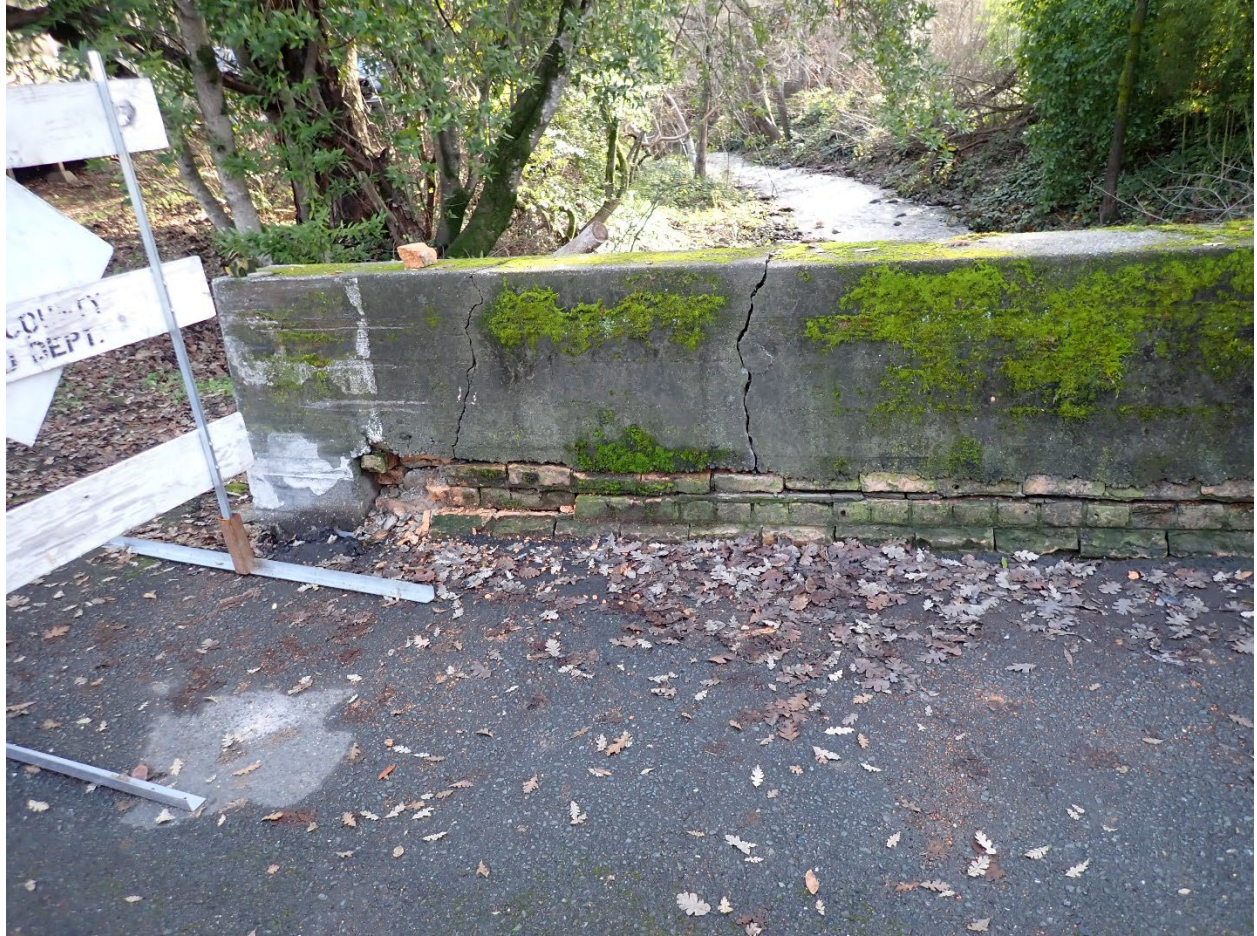
Photo 3 – Rail Damage

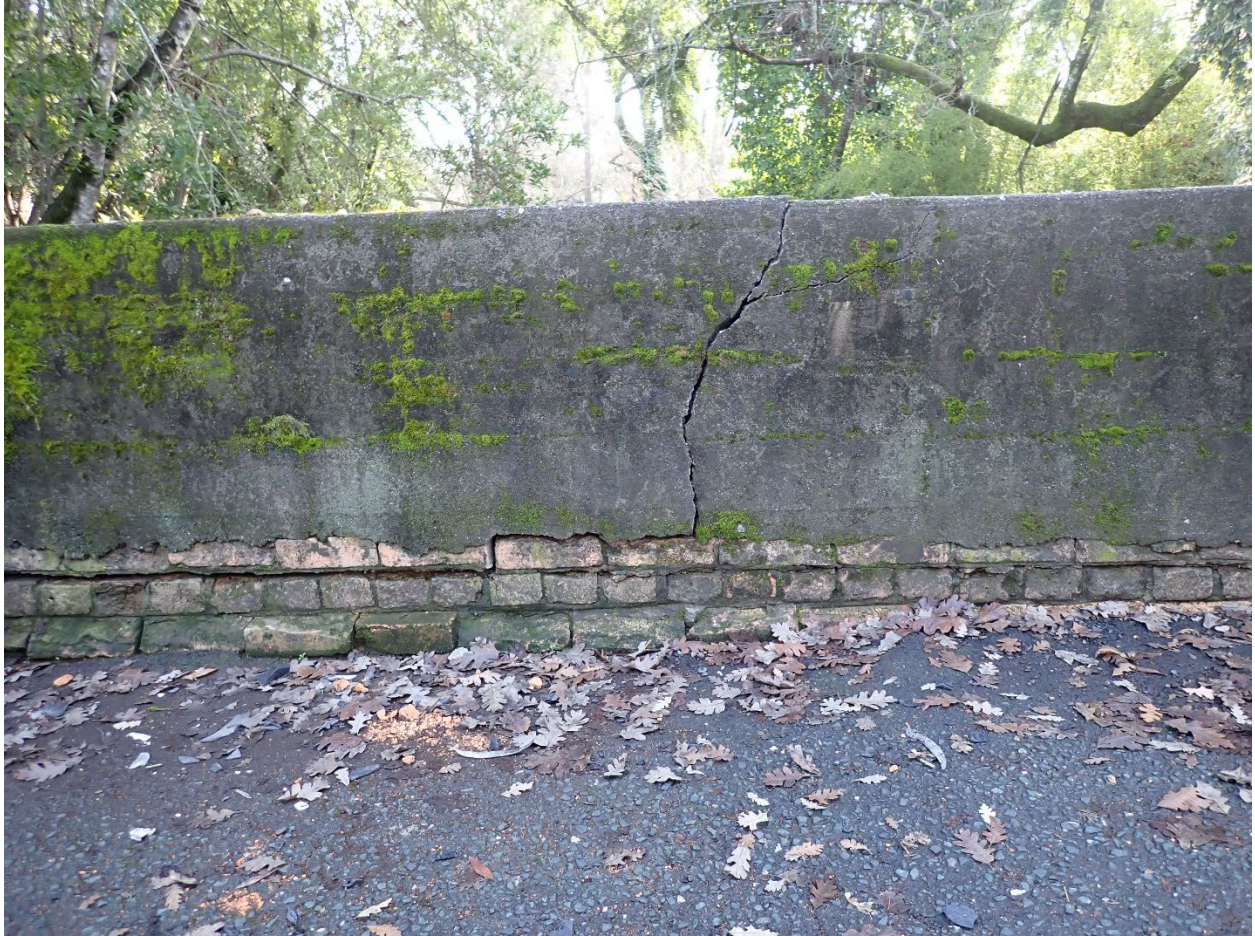
Photo 4 - Further Rail Damage
