BASELINE GEOMORPHIC ASSESSMENT OF TOLAY CREEK SONOMA COUNTY, CALIFORNIA

A REPORT PREPARED FOR SONOMA LAND TRUST

JUNE 2009

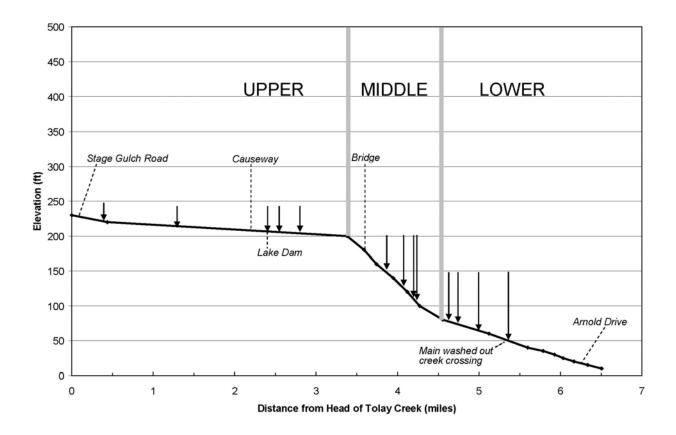
Figure 3. Longitudinal Profile of Tolay Creek Showing Breaks in Slope Distinguishing Upper, Middle, and Lower Portions of the Watershed. Profile constructed from USGS topographic maps. Arrows indicate location of tributary junctions.

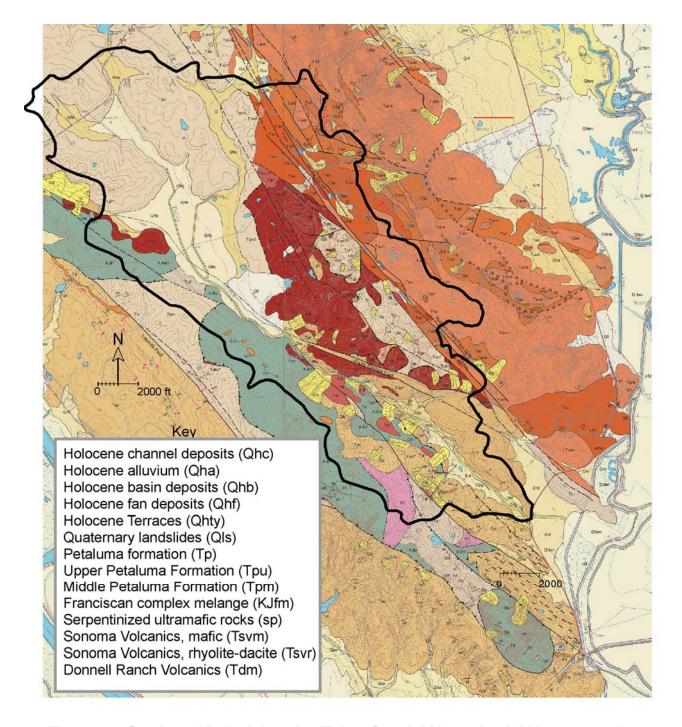
Tolay Creek flows in a basin with ridges formed by Tertiary volcanic and sedimentary rocks and the Jurassic-Cretaceous Franciscan formation. There are no quantitative measurements of erosion rates specific to the watershed; however, this reconnaissance level investigation suggests that these formations are erosive. Much of the hillslope area within the Tolay Creek watershed, especially on the southwestern ridge formed by Tertiary sedimentary rocks is mapped as "mostly landslide" (Wentworth et al., 1997). Geologic mapping (Wagner et al., 2002a and b) shows individual Quaternary landslides documenting unstable terrain that contributes sediment to Tolay Creek on a geologic timescale. For example, in the lower portion of the basin, the numerous Quaternary landslides on the northwest ridge illustrate hillslope instability (Figure 4). Recent high

The relatively young fault and fold structures that dominate tectonics in the Tolay watershed are associated with the San Andreas Fault System and include both the Tolay and Rodgers Creeks Faults (Figure 4). The dominant motion on these faults is strike-slip, meaning that the ground on either side of the fault slides past each other. The San Andreas system is a right-lateral strike slip fault: when standing on either side of the fault and looking across at the other side, the other side appears to be moving to the right. However there is also a strong compressional component to the fault motion, termed "transpression," as evidenced by local uplift and folding in the Coast Ranges. The transpression is normal to the northwest trending faults and folding and uplift of younger strata is exhibited adjacent to the fault zones.

The Rodgers Creek Fault zone trends northwest along the northeastern ridge of the Tolay Creek watershed and the related Tolay Fault zone is located along the slope of the southwestern ridge in the lower portion of the watershed (Figure 4). The Roche-Cardoza Fault cuts across the northeastern hillslope at an angle to both faults. The Rogers Creek Fault is thought to be one segment of the active Hayward-Rogers Creek-Healdsburg Fault system; however older structures are also prevalent in the watershed. The younger faults trend about N30°W and truncate older structures (e.g. the faults between tectonic terranes) that originally trended about N60°W (Blake et al., 2002). Most of the older faults dip steeply to the east and some may have been reactivated or realigned by younger tectonic deformation (Blake et al., 2002).

Figure 4. Geology Underlying the Tolay Creek Watershed (Wagner et al., 2002a and b).
